Manhole Inspection Summary

Manhole # S45MM_035MH

Insp Date: **3/24/08 1:56 PM**

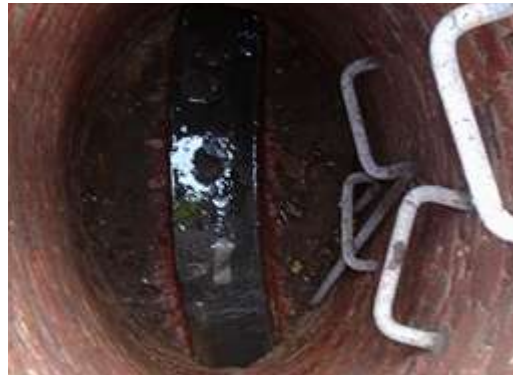
Top View

Frame Offset: **5** (in.) Condition: ☐ Sound ☐ Cracked ☒ **Leaks**

Condition: ☐ Sound ☐ Cracked ☐ Root Intrusion ☒ **Loose Brick** ☐ Deteriorated

Infiltration: ☐ None ☐ Joint ☐ Cracks ☒ **Mortar** ☐ Roots ☒ **Wall**
